Wastewater Management in Third World Cities: Case Study of Cotonou, Benin

Abstract

Urban Sanitation, Septic tanks, Soakaway Pits, Latrines, Desludging, Wastewater Treatment, Developing World Cities

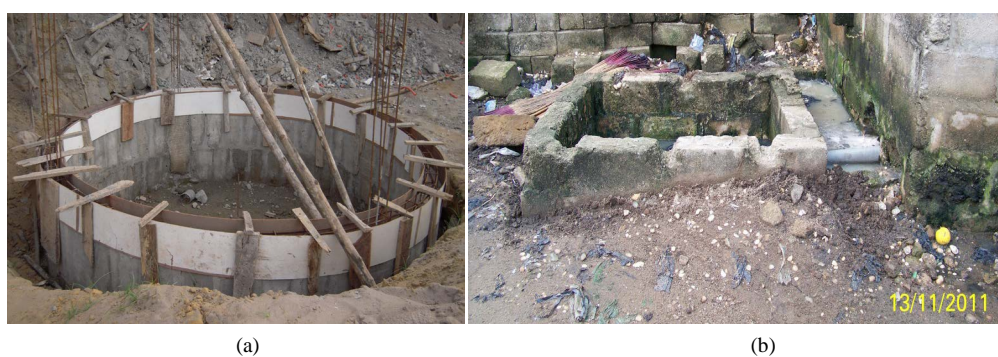
Figure 6. Soakaway pit. (a) under construction (b) current never emptied.

Most of soakaway pits were constructed of concrete blocks with cement lining (Figure 6(a)); some, however, were just a whole dug into the soil.

Due to the shallow groundwater table, soakaway pits discharge directly into the groundwater, especially during the rainy season when the water level in the soakaway pits rises due to the infiltration of groundwater. This makes desludging of the soakaway pits necessary because waters from the pits should not be allowed to infiltrate into the ground. For the same reason, the pits' depth is often very small, leading to the need for frequent emptying. 60.7% of houses having soakaway pits desludged them. 54.9% of the houses (that means 90.4% of those who desludge their soakaway pits) desludged their soakaways at most once a year. On the other hand, 39.3% of houses do not empty their soakaway pits; they leave them running onto the street, the backyard or the courtyard (Table 3, Figure 6(b)).

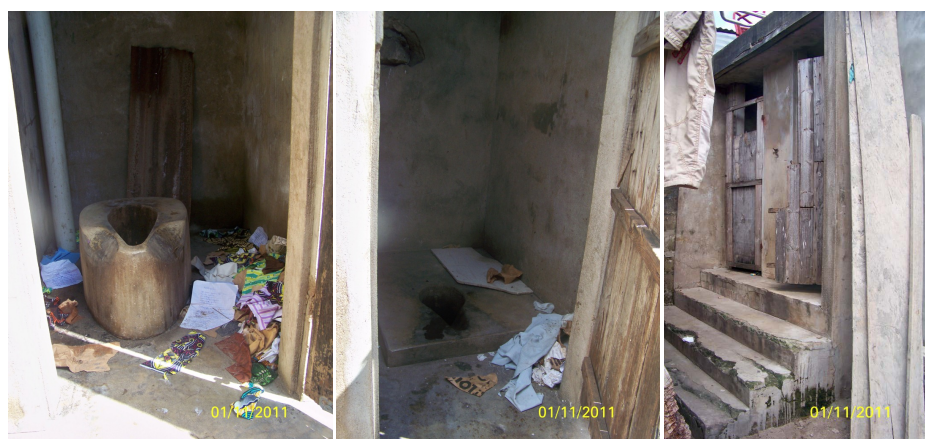
Figure 7. Typical traditional latrine in Cotonou and anal cleansing materials.

Most of the houses in Cotonou (82.7%) were using individual sanitation facilities (traditional latrine, septic tank). The superstructure of latrines is usually made of brick with cement mortar (rarely in bamboo or sheet metal) and roofed with sheet metal or a solid concrete slab. The pits consist of a concrete slab or cement mortar base, with the sides in brick coated with cement mortar and covered by a concrete slab with a hole to receive the excreta. Almost all the pits had a depth of between 1.0 and 2.5 m, due to the shallow groundwater table. In the case of depths greater than 1.0 m, the remaining part of the pit was an above-ground superstructure (**Figure 7**).

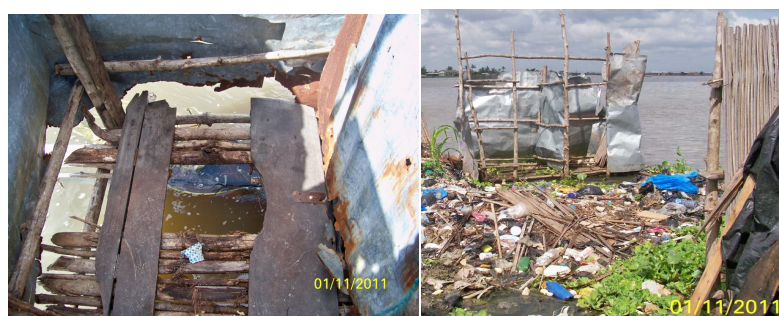
Figure 8. Lagoon latrine.

Of surveyed houses, 15.1% did not have any toilet facilities (**Table 5**); they used their neighbours’ latrines, public latrines (9.0%), or practised open defecation. Those close to the lagoon had built structures on the lagoon which are used for privacy when they defecate directly into the lagoon. These are called “lagoon latrines” (**Figure 8**). This percentage (15.1%) is far higher than that (5%) observed through a survey in Ouagadougou [6] but lower than the estimated percentages for urban areas in Benin (31% for open defecation and 34% for shared facilities) and for Sub-Saharan Africa urban areas in general (25%) by WHO [4] [5].

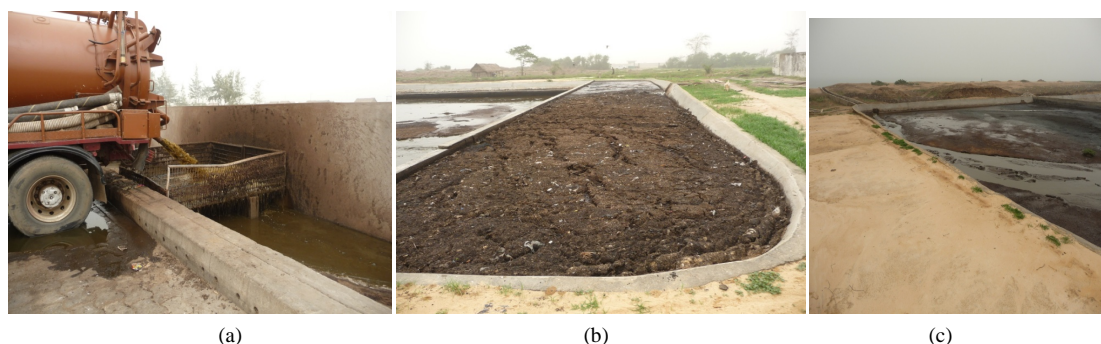
Figure 9. The treatment plant. (a) The grit chamber; (b) The anaerobic pond; (c) From the third WSP to the sea.

Trucks entering the plant discharge their content through a bar screen into the grit chamber (**Figure 9(a)**). From this point the wastewater flows to the anaerobic pond (**Figure 9(b)**).

The effluent from this pond is normally diverted into two series of three aerobic ponds working in parallel, though since 2009 one series has been shut down for the removal of the baffles, which made desludging difficult. Thus, during period of our survey work at the site (September 2009 to April 2010) only one series of ponds was receiving all the incoming wastewater. The liquid effluent from the third pond is directed to the sea. The ponds were full of sludge (**Figure 9(b)** and **Figure 9(c)**). The depth measured in each pond from the top of the sludge to the inlet or outlet was less than 10 cm. This vastly reduced the retention time down to less than one hour, with a serious effect on the effluent quality.
